Installing Bushing in Throttle Arm

RevoLT

SD-1003

Evolution Aircraft, Inc

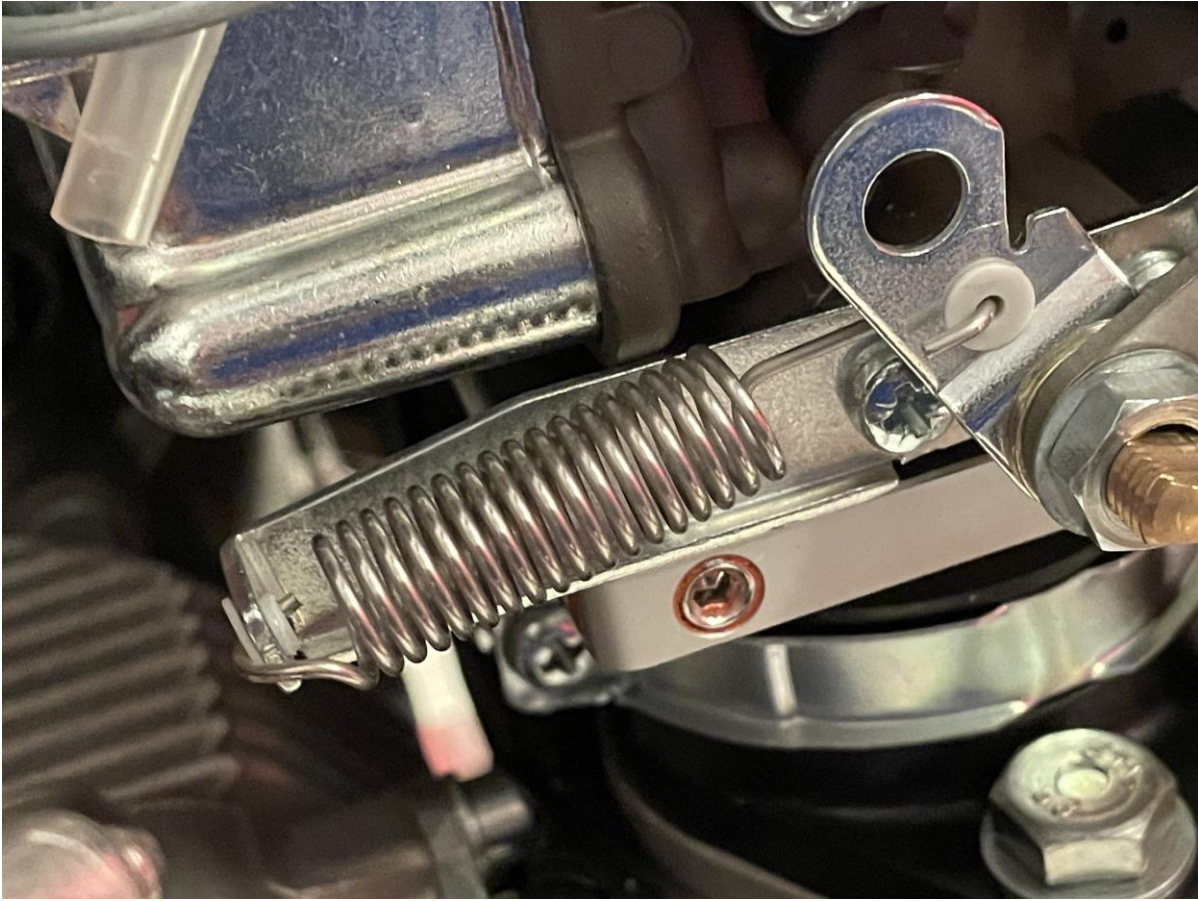
Throttle return spring broke during flight on an aircraft which then caused the carburetor to not return to idle. It was found that wear caused the spring hook to fail prematurely on the throttle arm. Inserting a plastic bushing reduces this wear.

- Remove spring by unhooking lower section of the spring by placing a small plastic zip tie around the hook to remove it. Do **not** use pliers, which may damage the spring.
- Rotate 180° up and unhook top (throttle arm does not need to be removed).
- Enlarge spring hook hole and throttle arm using .161in drill bit.
- Press plastic bushing into hole.
- Reattach spring starting with the hook in the new plastic bushing.
