**Evolution Aircraft, Inc.
39440 South Ave.
Zephyrhills, Fl. 33542**

SAFETY ALERT

**Rear Keel strap wear
SD-1017 RELEASED October 5TH 2015**

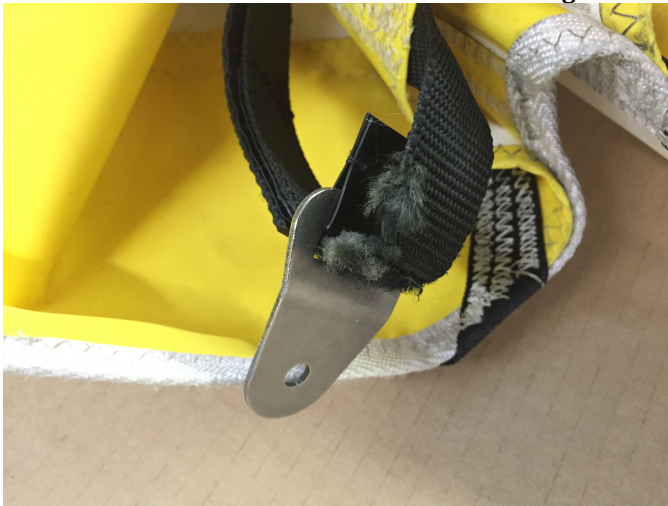
Check your rear KP strap for wear at the tang. We think this was partly caused by the tang not able to move a little. You should be able to move the tang by hand fairly easy. If the tang is too tight the webbing move to the out side and the slot corner start fraying the webbing. The other cause can be the plastic protector inside the tang slot simply cut through and now the webbing has direct contact to the tang edge.

- 1) Ensure the tang can rotate easily. If the tang cannot rotate easily, loosen the tang so that it can rotate
- 2) Optionally we have a new protector on the tang now. We use a tube to make a better, rounded area that the webbing goes around.
- 3) To update your tang we can send you the piece of tube for no charge or you can order a complete tang with the tube installed directly from Northwing at (509)682-4359.
- 4) If the strap is damaged, email a photo of the damage to evolutiontrikes@yahoo.com and wait for further instruction.
- 5) In all cases if the tang can move freely and there is no excessive wear on the strap, the SD has been completed. It is up to the owner whether or not they will replace the tang.
