**Tip Cap / Tip Webbing
Safety Directive -SD501
Status: Mandatory
All Wings grounded till complied**

Date: July 10, 2024

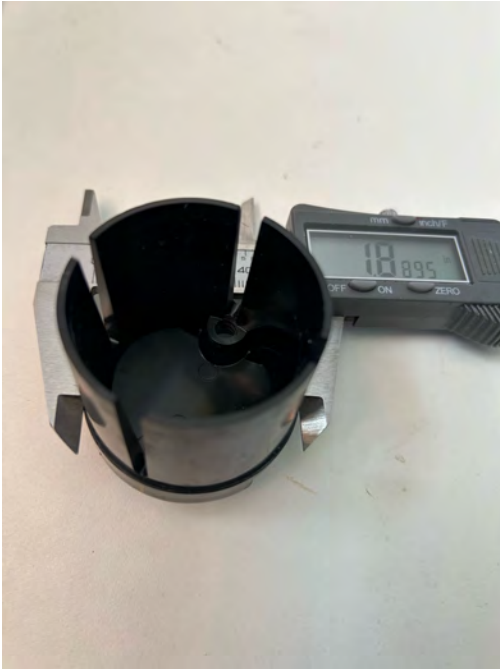
We had a run of tip caps that ran small on the body and the rim.
ID 1.838" to 1.860"
They should be 1.884 to 1.891 (ranging .025 to .45 smaller)
Your cap body should not be less than 1.884

**Body measurement
Good 2013 tip**

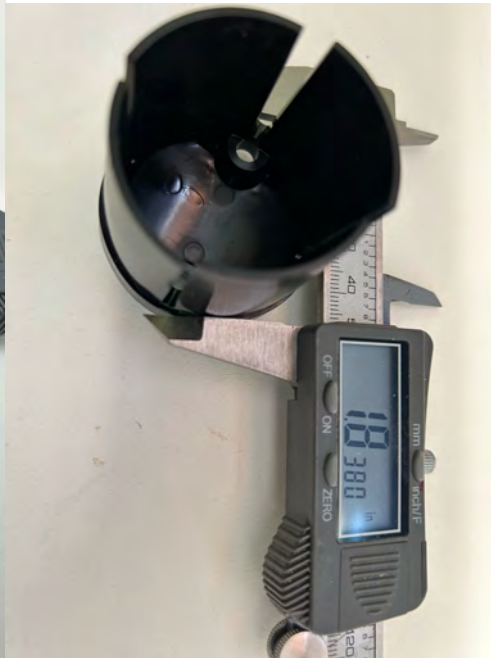
Bad 2023 tip

If you need to replace your tip cap we can sell you new 3D printed ones for \$60.00 for 2.

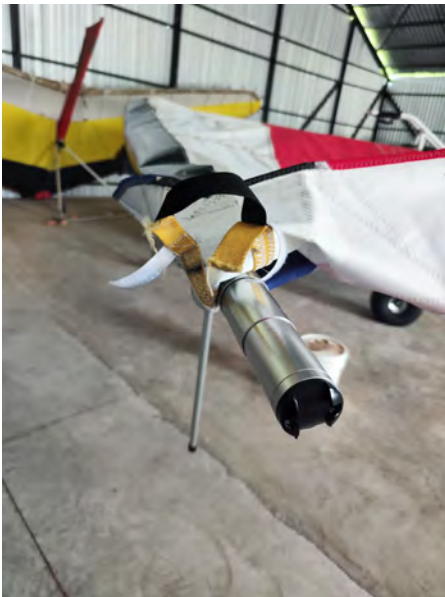
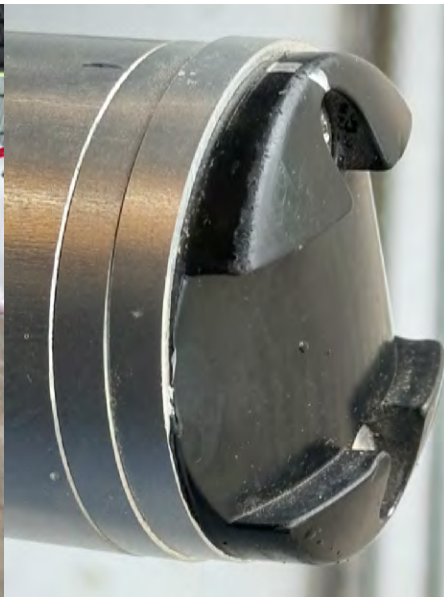
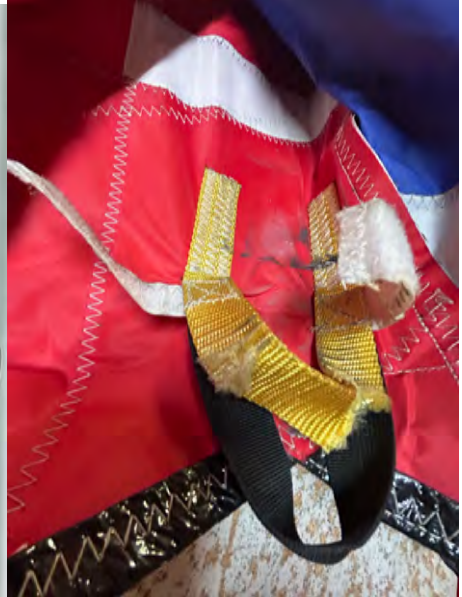
Bad tip cap needs replaced

Bad webbing - needs replaced

Tip Cap pressed down into the Shim and alum edge can cut the Webbing

If your webbing is worn and needs to be replace we will replace webbing at no charge.
Shipping cost of the sail and time we will not cover.

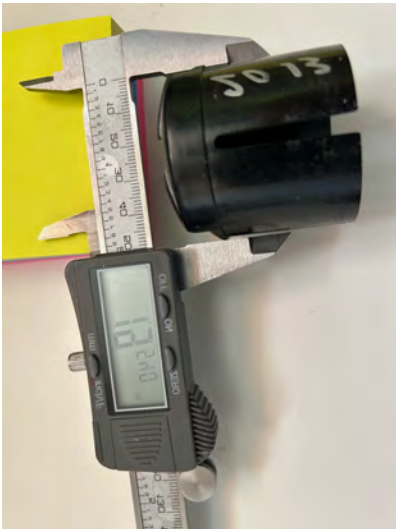
Good Tip Caps 2021 or earlier
Outer lip should read 1.950 to 1.955

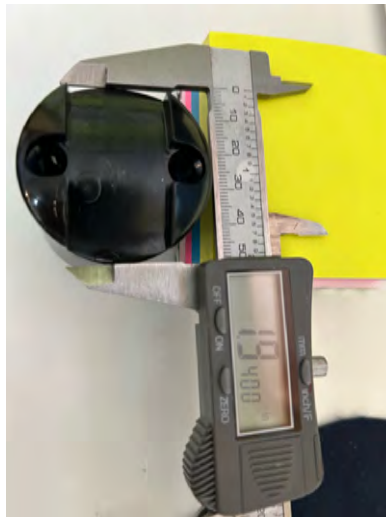
Could be Bad caps 2021 or newer
Newer (bad) caps showing 1.940
