A Pulse Line Replacement RevX

SD-1003

Evolution Aircraft, Inc February 19, 2025

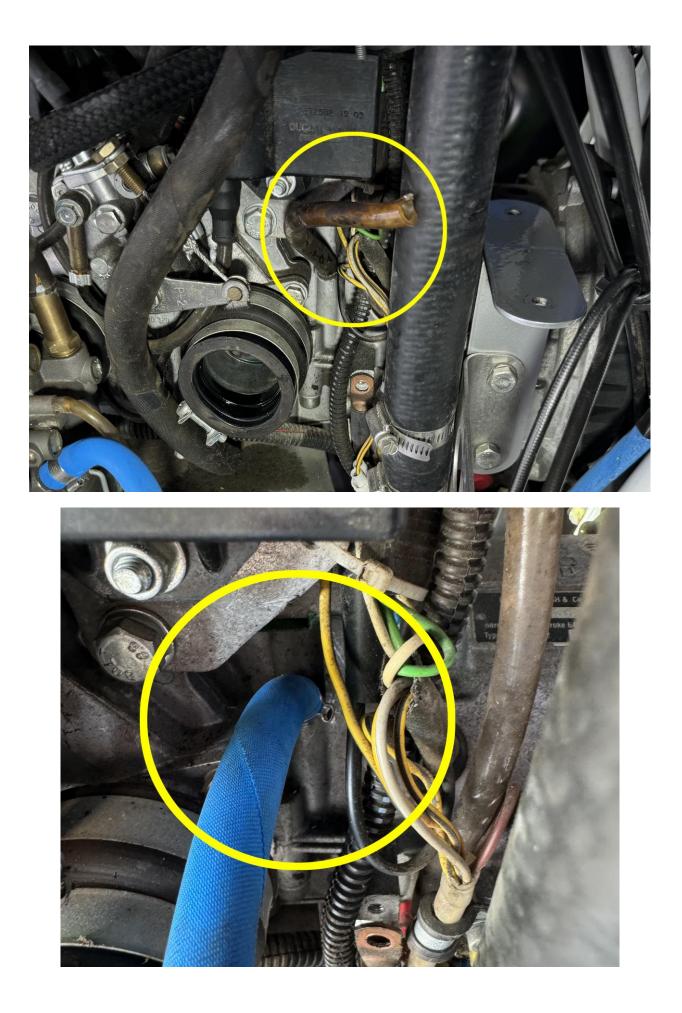
It is possible for the pulse line that powers the mechanical fuel pump to fail within 5 years. Therefore this line is being changed to Aeroquip fuel line and should be checked annually and replaced at 5 years or on condition.

- Remove airbox
- Remove right side carburetor
- Remove airbox bracket
- Remove Adel clamp that holds rotary valve to engine case
- Remove Oetiker clamps on both ends of line
- Replace line
- Install new Oetiker clamps
- Reassemble
