1/4" Anti-Rotation Bolt

Rev

SD-1002

Evolution Aircraft, Inc

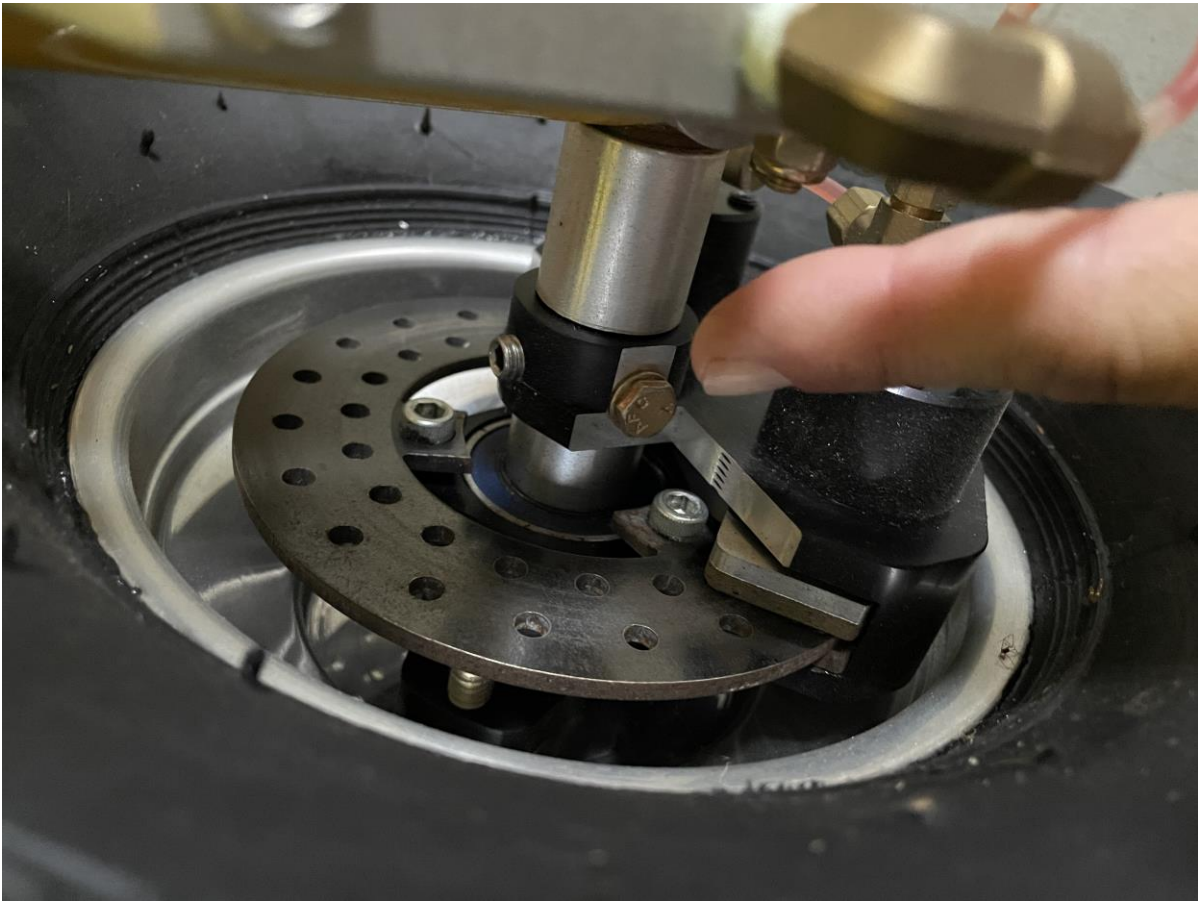
It is possible to shear the AN-3 bolt that goes through the front axle and brake caliper during braking. This will cause brake failure. Upgrading to an AN-4 bolt will strengthen this area.

- Loosen clamp bolts on triple trees and remove fork tubes.
- Remove axle bolt from right fork tube.
- Slide wheel off axle.
- Remove AN-3 anti-rotation caliper bolt.
- Enlarge 3/16" hole in axle and caliper to 1/4".
- Reassemble using supplied AN-4 bolt.
