# **1/4" Anti-Rotation Bolt**

**RevX**

**SD-1002**

**Evolution Aircraft, Inc**

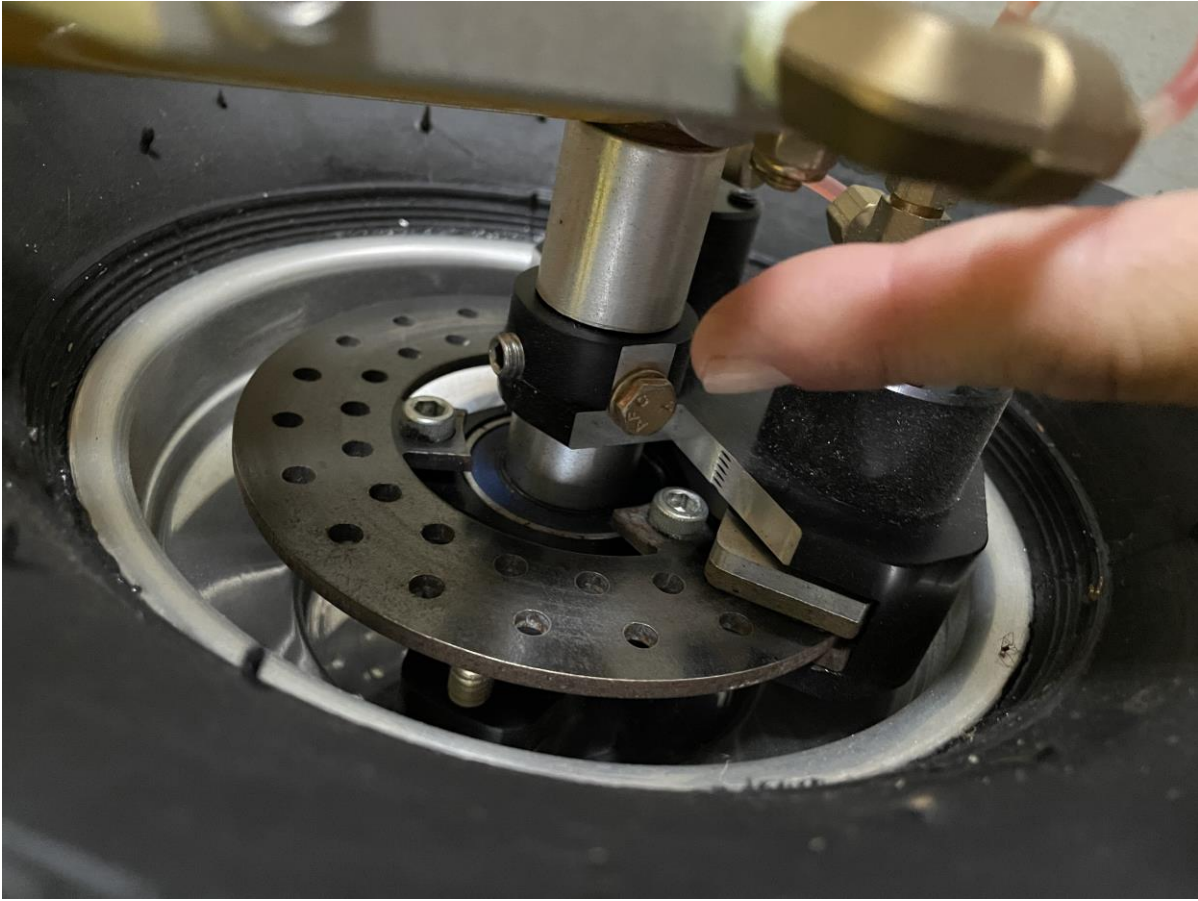
It is possible to shear the AN-3 bolt that goes through the front axle and brake caliper during braking. This will cause brake failure. Upgrading to an AN-4 bolt will strengthen this area.

- Loosen clamp bolts on triple trees and remove fork tubes.
- Remove axle bolt from right fork tube.
- Slide wheel off axle.
- Remove AN-3 anti-rotation caliper bolt.
- Enlarge 3/16” hole in axle and caliper to 1/4”.
- Reassemble using supplied AN-4 bolt.
