SAFETY ALERT

Inspecting gascolator bowl for corrosion on a REVO

SD---1012 Released August 13th 2013

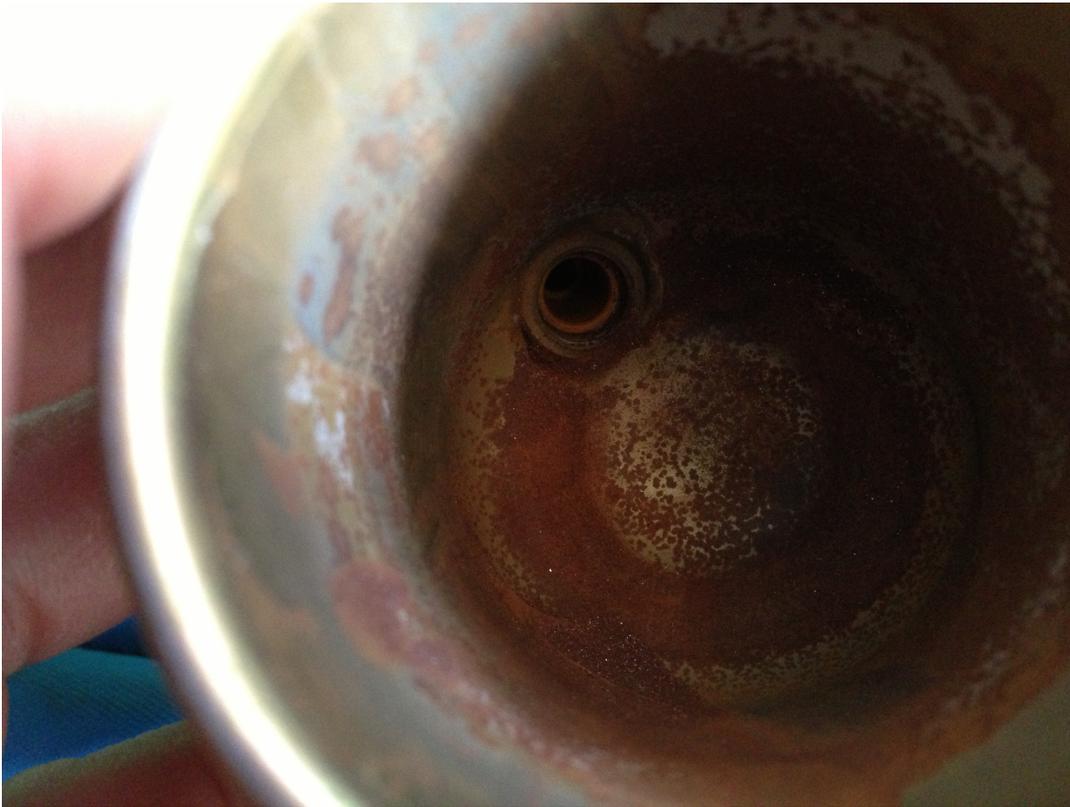
In one case we have found excessive corrosion in the bowl of the gold ACS Gascolator installed on a REVO

This is how to comply with this directive.

- . 1) Open the ASC gascolator and inspect the finish inside the bowl.
- . 2) If the finish appears factory new, put the bowl back on and continue using the aircraft and check the bowl during each 100 hour annual inspection.
- . 3) If there is any sign of corrosion, rust, or anything other than a shiny finish, the entire gascolator should be replaced with an Evolution Trikes manufactured all aluminum gascolator.
